<p>A Short and Long Term Evaluation of along Shore Geomorphological Changes in the Danube Delta <i>(Alina-Daiana Spînu, Emanuela-Maria Mihailov, Luminița Buga, Dănuț Diaconeasa)</i></p>	<p>“Cercetări Marine” Issue no. 48 Pages 161-170</p>	<p>2018</p>
---	---	--------------------

A SHORT AND LONG TERM EVALUATION OF ALONG SHORE GEOMORPHOLOGICAL CHANGES IN THE DANUBE DELTA

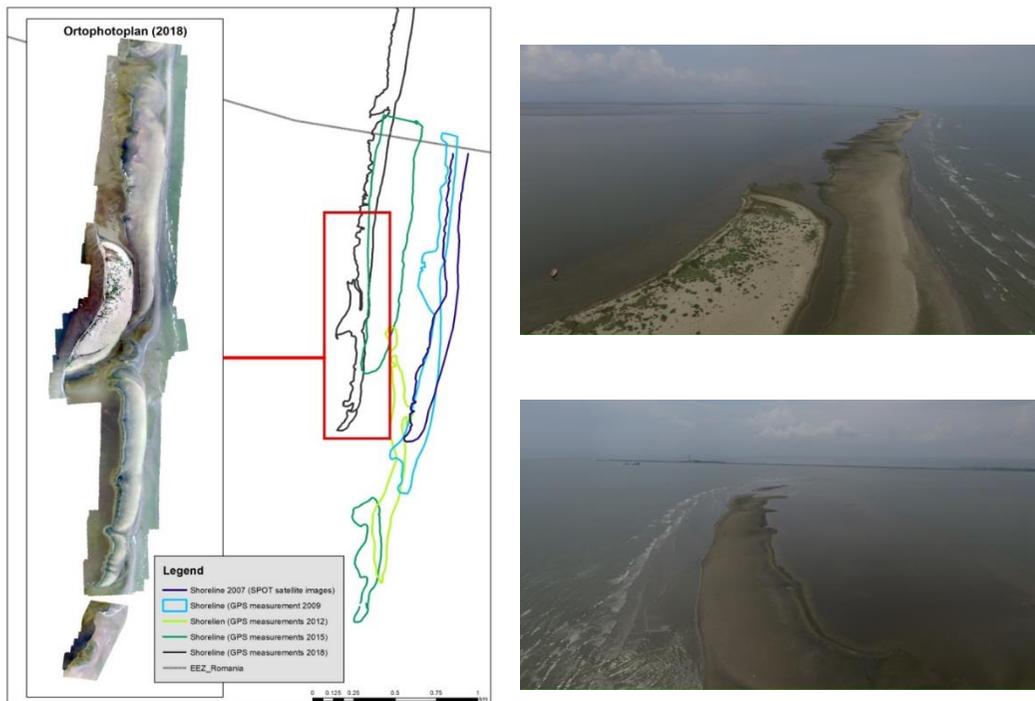
Fig. 1 Musura island (morphological evolution 2007-2018).

GPS measurements show that, in 2007-2009, the barrier island lengthened 180 m in the direction of WSW-ENE. In March 2010, the barrier integrity was severely affected as a result of the 8-9 March storm that occurred in a period of high sea level due to historical floods on the Danube (Fig. 1).

Thus, for a length of approximately 2 km of shore, in the period 2007-2018, there were average withdrawals / translations of 40-50 m year, the actual island being translated more than 500 m inland.

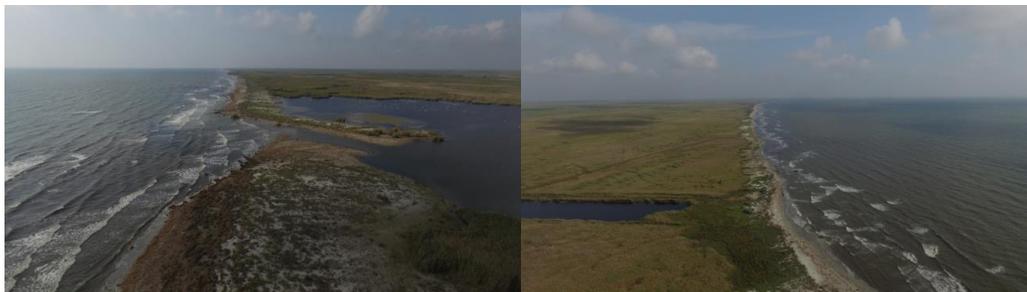
Fig. 2. Garla Împutitei - Câșla Vădanei sector.

of the sector, between Garla Imputita and the Cazacu sandbank, about 10 km, the shore is fragile, consisting of fragments of coastal belt with a height of 0.5-0.6 m and width not exceeding 30 m (Diaconeasa, 2009). In many sectors reeds and reed islets fixed to the ground get close to the shoreline, being washed away by the waves. In this sector, in periods with high levels of the Danube waters, forms the numerous breaches, the delta drainage into the sea (Fig. 2).

The annual erosion rates calculated showed an average of ~ 5-20 m/year. Between 1975 and present, the erosion process of the beach is particularly intense, the shore being over 600 m in certain sectors.

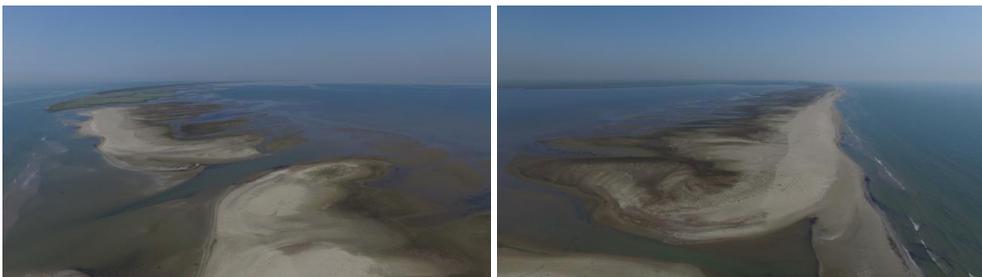
Fig. 4. Sahalin peninsula (aerial images, 2017).

The sector is vulnerable from morphologically point of view, the shore on ~3 km being destroyed by extreme storms during the cold season in 2013, currently undergoing a recovery process (fig 4, fig. 5).

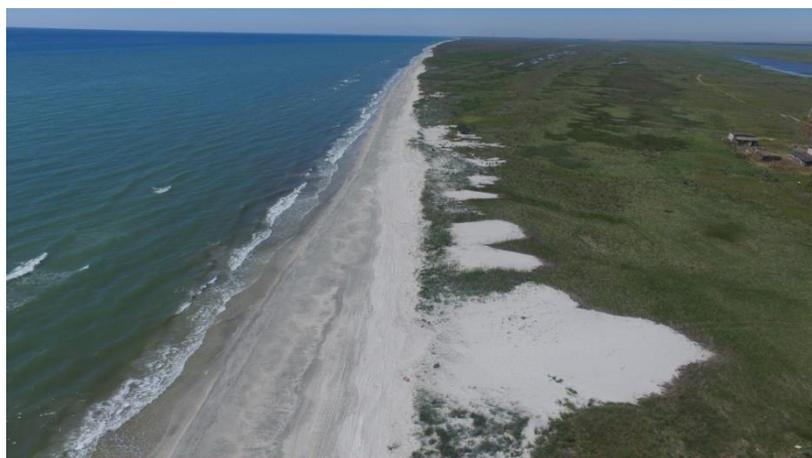
Fig. 8. Photo of the Chituc sandbank.

The Chituc sandbank (Fig. 8), with a length of approximately 20 km, was formed by the joining of several successive coastal belts in the direction of the ENE-WSW. The erosion occurs in the northern part of the sector, and continues ~10 km to the south (Spînu, 2017). In the southern part of the sector, the shore becomes typically accumulative, with broad beaches and sand dunes, the shoreline advancing between 1962-2017 with approx. 4-5 m/year.
